MISSOURI - KANSAS CITY RIVER BASIN

BOCO MO DAM
BOONE COUNTY, MISSOURI
MO. 10893

PHASE I INSPECTION REPORT NATIONAL DAM SAFETY PROGRAM

SEPTEMBER, 1980

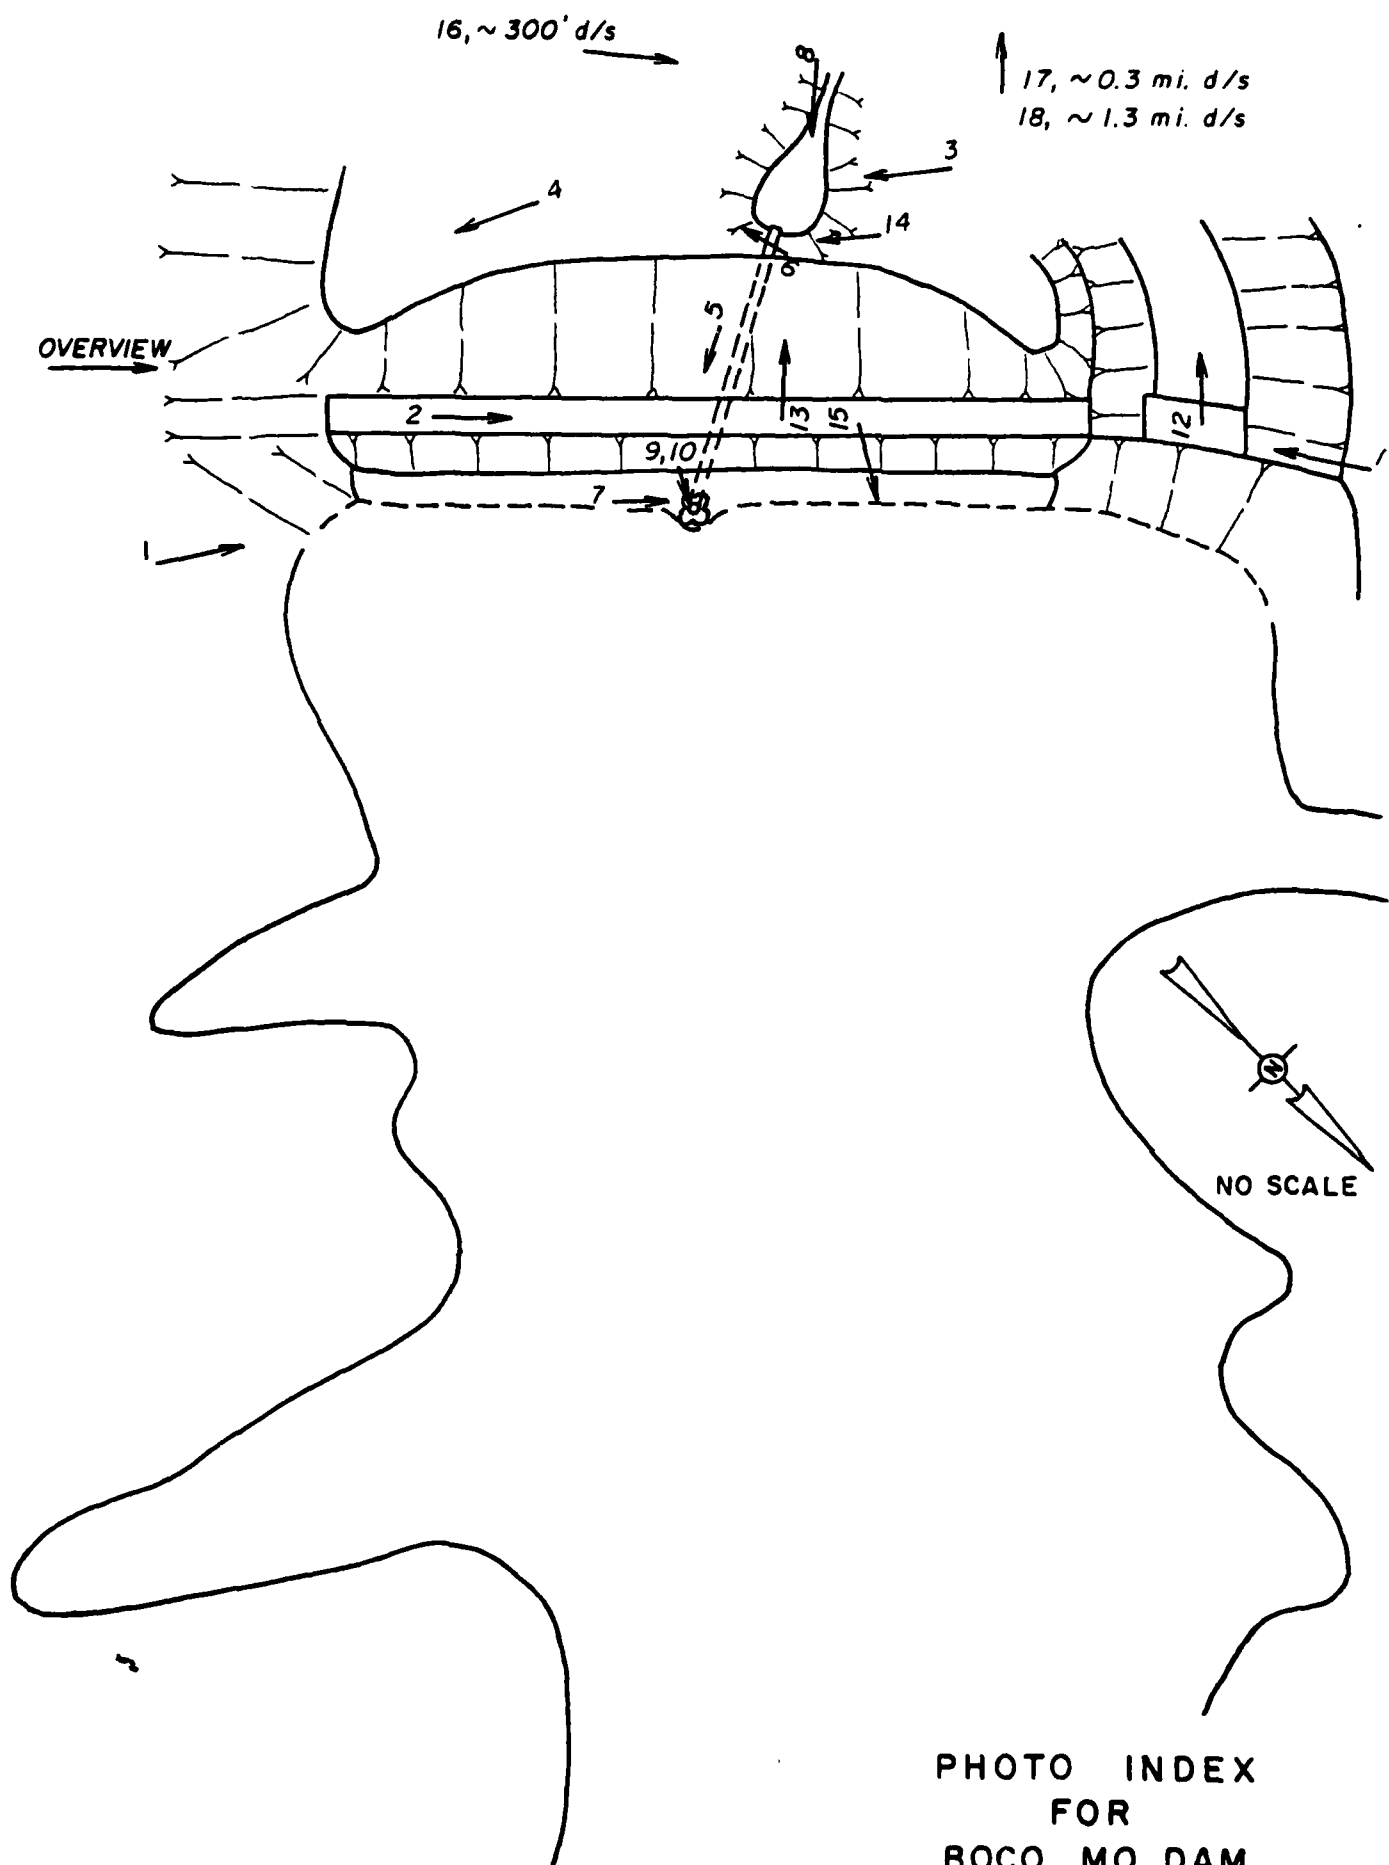
- Photo 1 - Overview of the upstream slope showing the location of the service spillway drop inlet and the wave erosion along the berm.
- Photo 2 - View of the top of dam looking toward the right abutment.
